Accident Reference: 13-2010

Air Accident Investigation Interim Report

Boeing 747-44AF
N571UP
Dubai
United Arab Emirates
September 03 2010

General Civil Aviation Authority of the
United Arab Emirates

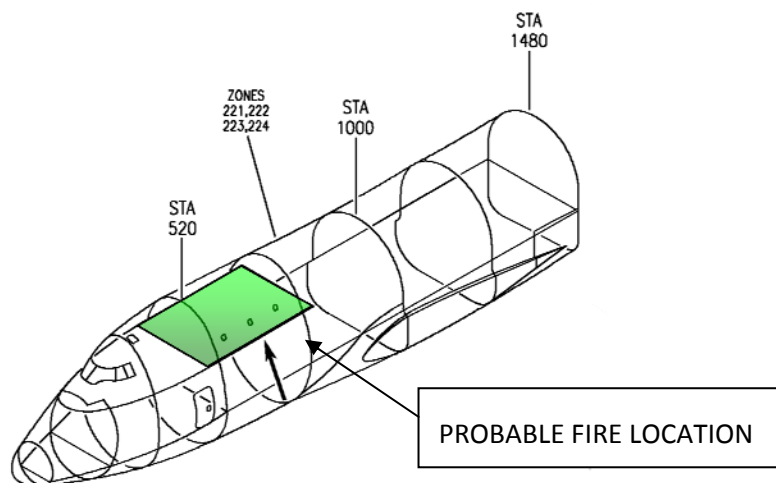
FIG 4: MAIN DECK CEILING PANEL DIAGRAM STATION 400 TO 718.40

The linings in the proximity to the probable location of the fire zone are shown below in green.

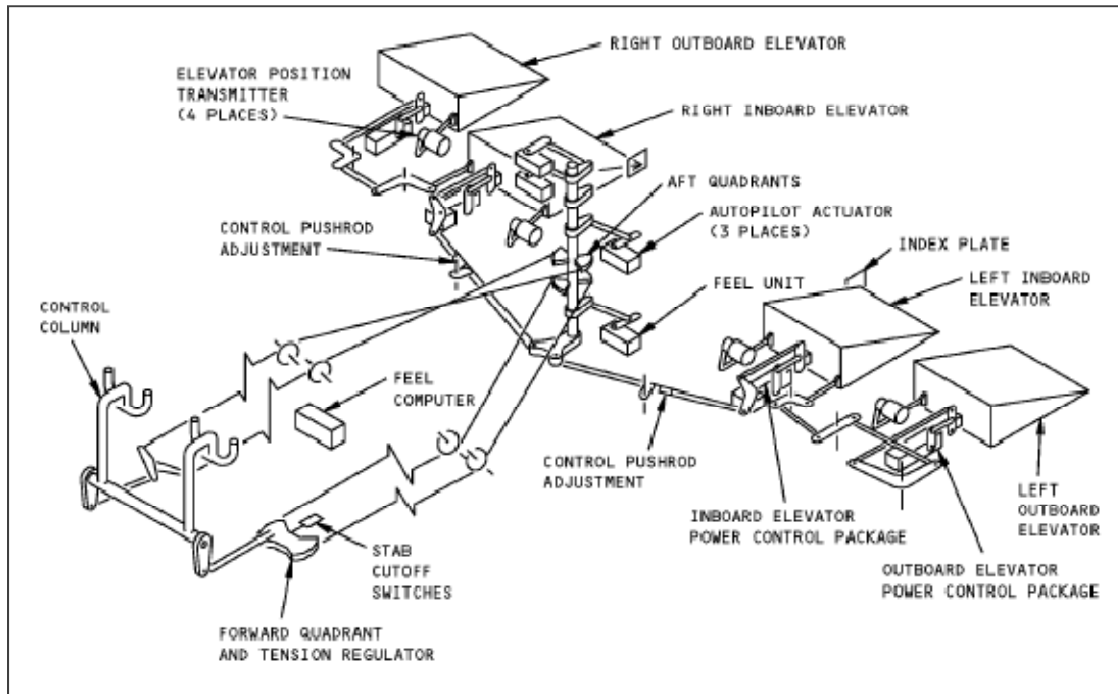
FIGURE 12: ELEVATOR CONTROL SYSTEM SCHEMATIC FROM THE AIRPLANE MAINTENANCE MANUAL

All of these indications are consistent with a decrease in elevator control cable tension.

The elevator control system schematic is shown in Figure(12). The cable that connects the forward and aft quadrants requires tension for the column movements to translate into elevator movements.

The elevator control system in Figure 12 above is designed so that a unit of column deflection creates a unit of movement in the aft quadrant (which in turn moves the elevators). The consistency of this system requires a prescribed tolerance of tension in the elevator control cable.

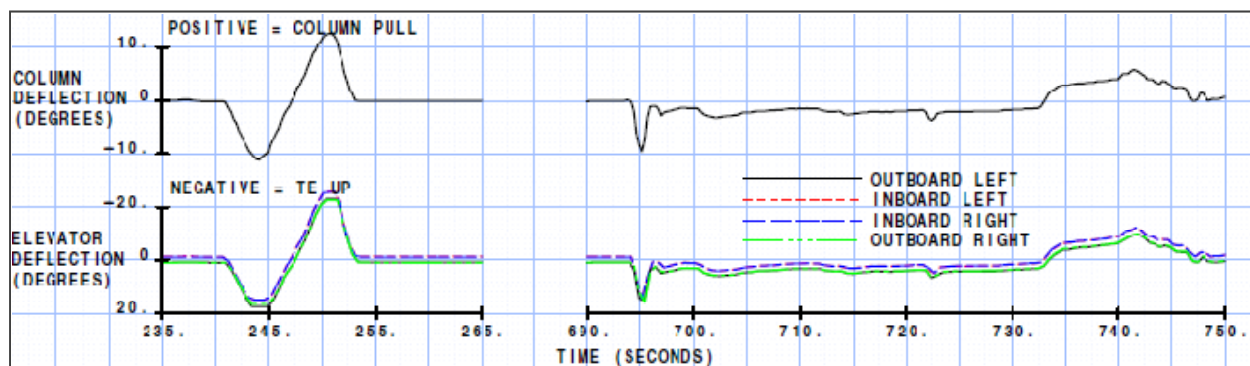
FIGURE 13: COLUMN SWEEP AND TAKEOFF ROTATION

Column sweep and takeoff rotation display the normal relationship between column and elevator. If the tension is below the allowable tolerance, the column and elevator will no longer be consistent.

Following the initial fire warnings the column moved nose-down with no corresponding change in elevator deflection (left plot Fig. 13 above).

Near the end of the data, the FDR data shows nose-up column inputs (right plot Fig. 13 above).

The elevator was deflecting with the column inputs but not with the relative magnitude seen in Figure 13. This indicates that there was some column cable tension but not enough to maintain normal column to elevator gearing

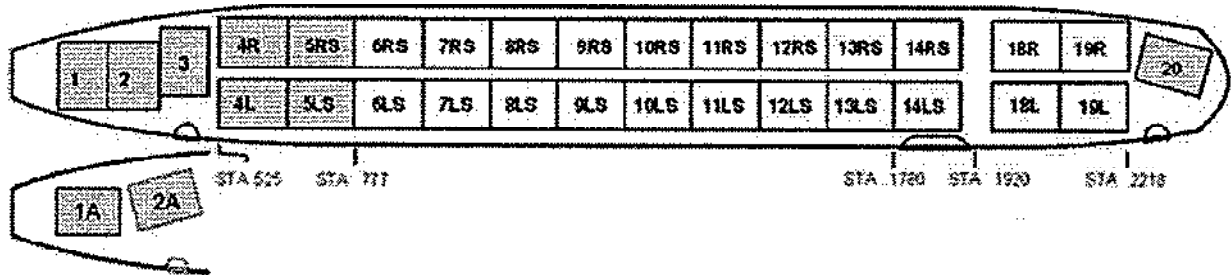
Figure 1 - Cargo Configuration of UPS6 aircraft main deck

The following cargo was removed from inbound UPS flight 6, as final destination cargo at Dubai, UAE: 14LS, 18L, 19L, and 45 pieces of loose cargo located in Aft Bulk (AB). Additionally, approximately 2,770 lbs of cargo was transferred from the ULD in position 13L to the AB loose load position to establish the new AB cargo weight of 4,020 lbs. At this point, a bulge in the collapsible ULD in position 18R was identified by Dnata²¹ loaders working the aircraft. The bulge indicated that a load shift of packages occurred inside the ULD. According to UPS personnel at DXB, one package fell out of the ULD, from a height of approximately 5 feet. In order to remove the ULD in position 18R, the ULD in position 14R was removed and placed on the ramp. The ULD from position 18R was removed and transferred to the UPS operations hub at DXB to be reconstructed. Following the reconstruction of the ULD from position 18R, UPS indicated that a ULD serviceability check was performed. New ULD's were loaded into positions 13L (3,969lbs), 14L (4,697lbs), 18L (6,240lbs), and 19L (2,963lbs). Along with these ULD's, the reconstructed ULD from position 18R and the ULD from position 14R were reloaded onto the aircraft into their respective positions. Figure 1 shows the cargo configuration of the UPS Flight 6 aircraft main deck.
